WORKDAY SUMMARY - 21 JANUARY 2017:

Work done on 15F 3046 on Saturday included:

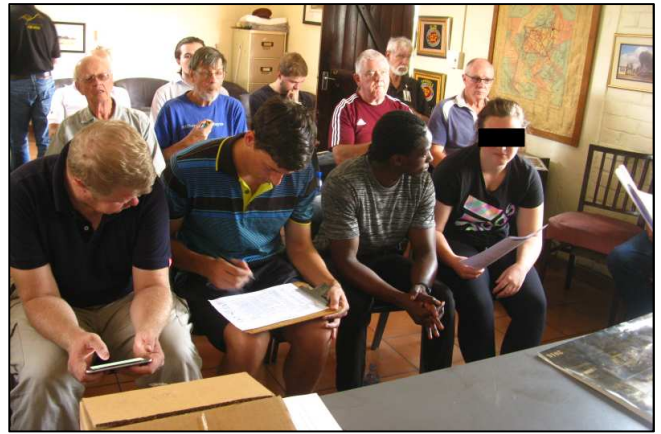
P01 - The Coachies started their new Reefsteamers Year off with a refresher training session. They were discussing fire-fighting and how to prevent passengers from panicking – always a risk when the human-herd instinct takes over with lots of people in a confined space.

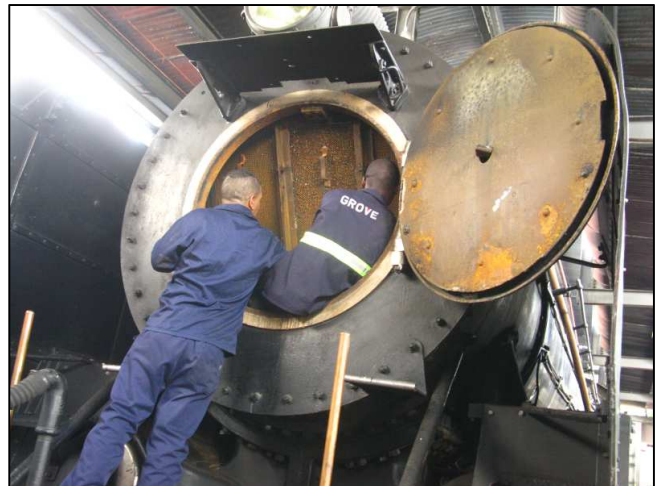
P02 - We have a new batch of Africa Academy Appies to torture ... I mean ... train up. This likely bunch were tasked to put 15F 3046's smokebox and arrestors back together again. It was dismantled and left partially open through the quiet months of December to dry out after cleaning.

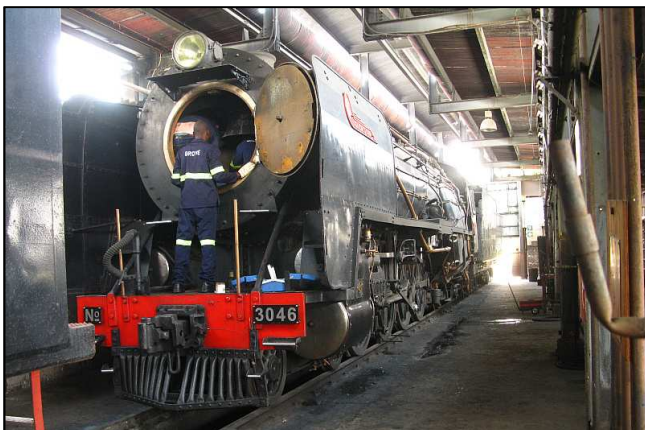
P03 - 12AR 1535 and 15CA 2056 are both booked in for major repairs from the start of the year. But we had to put our efforts into this old 15F clanker to get her steamed-up for our first run of the year on Sat, 28 Jan 2017.

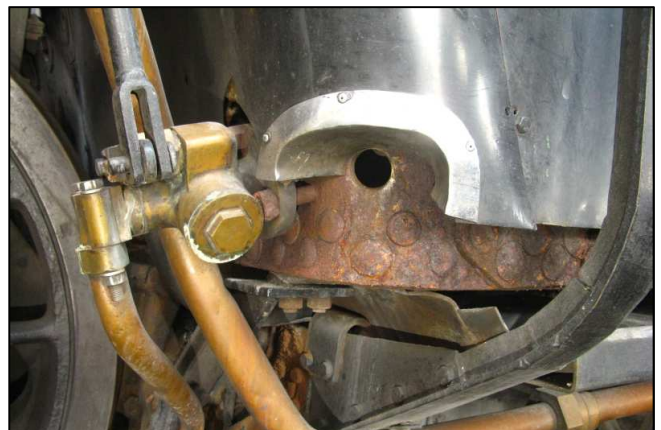
P04 - Several of 15F 3046's washout plugs had been removed as well to allow a gentle, healthy drying draft in the boiler's water space through December.

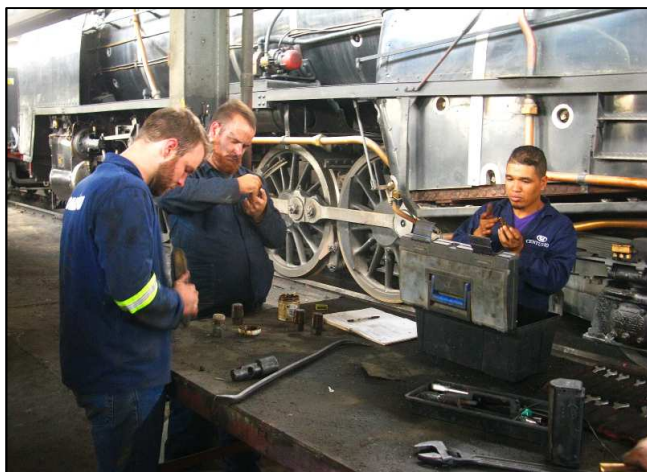
P05 - A little later and the Appies are seen busy cleaning and copper-greasing the conical threaded washout plugs to be put back in. They might be doing coach lifting next week!

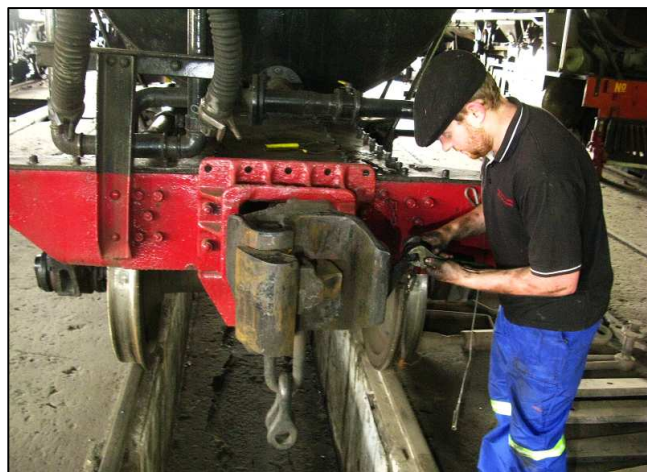
P06 - Bossy the Tanker got a new coupler cut cable fitted. The clevis bolt had seized, so after some fruitless battles with spanners, they 'cooked' the bolt off with alternate torching and then quick-quenching with cold water.

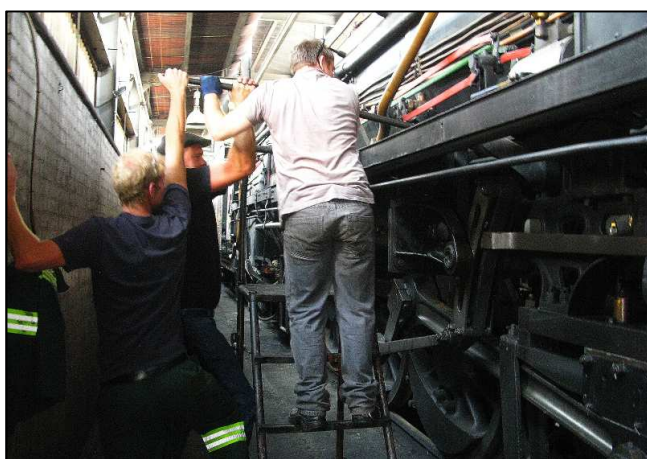
P07 - Work needed to be done on the left side die block. So the radius rods had to be manually shifted upwards to allow for access. This is how you 'change gears' on a stationary cold steam locomotive, and you have to disconnect the locking cylinder of the power reverser first.

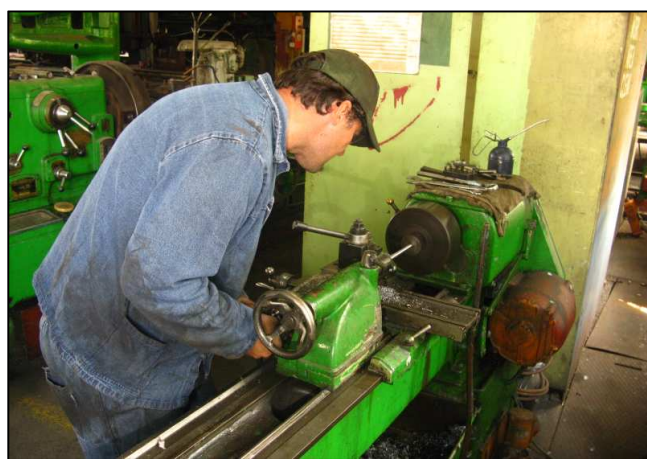
P08 - Meanwhile, Dawie is seen machining a new Die Block Locking Pin from rod stock that was slightly oversized. For some reason, Midas Motor spares don't stock 15F parts. Very inconvenient...

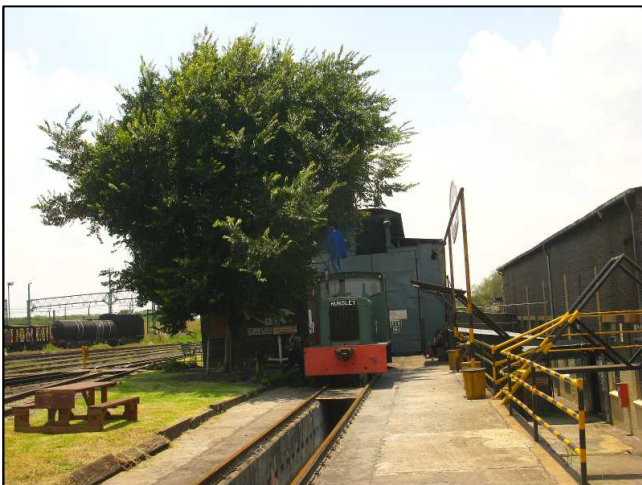
P14 - Cousin Rob got some outdoor exercise today - clipping away at the languidly overhanging branches of the T&P tree. It no longer reaches in cheekily through the cab windows, but it has grown so tall the debris snag at the top of the locos, among the turrets, spindles and the like.

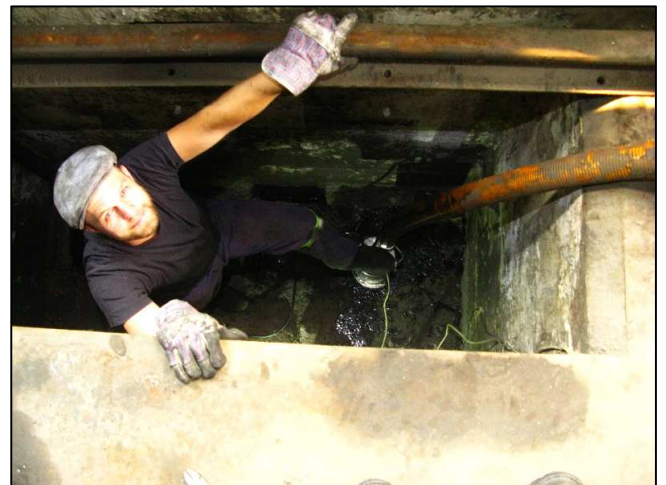
P15 - The sump pump in the wheel drop pits had failed - someone had left it switched on and the dry pumping damaged the seals. (It is manually operated.) That's the magnificent Darryn doing the lower end of the installation with Donovan (not seen) doing the pipe work.

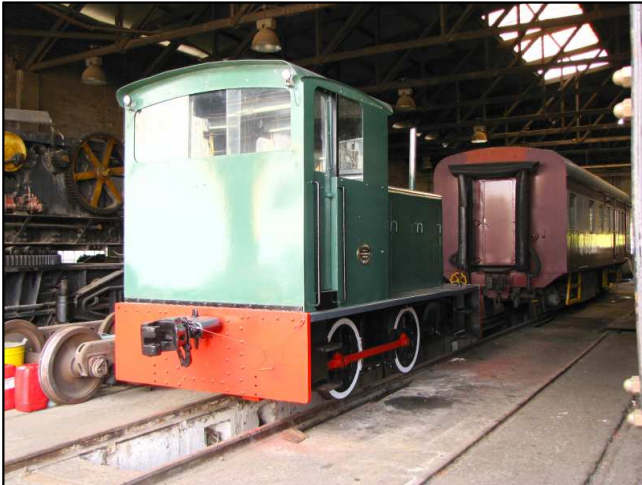
P16 - Just over 7 years ago, 'Andrew' the Hunslet ran for the first time after his overhaul and open-engine surgery, including a repaired gearbox. He had been laboriously sanded down (By Dianderson) and repainted in a typical Hunslet green livery. Unfortunately, due to time pressure, one of the gears hadn't been case-hardened properly and so the gearbox job had to be repeated a little later. But barring abusive driving, the gearbox should now last many more years, although he presently needs a new paint job and attention to the drive rods.

Donovan and Darryn will be doing the next major service.

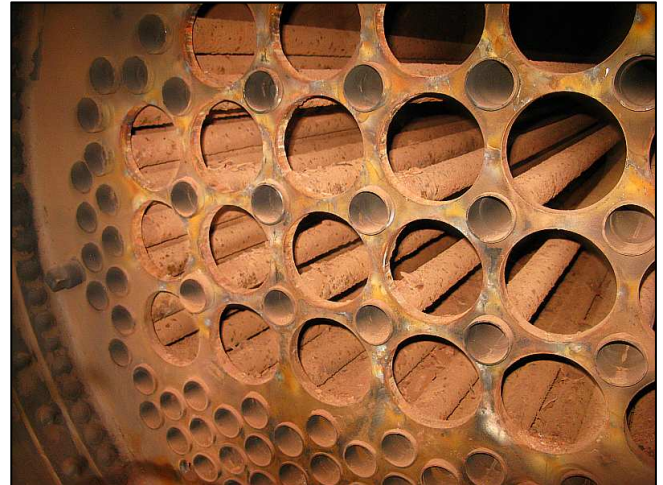
P17 - When is a boiler's Fire Tube called 'A Flue.' The international convention is when it exceeds about 5 inches in diameter. A modern 'Flue' within a single-pass fire tube boiler (like this one on the 15CA) serves the same purpose as a tube, but also houses compact bundles of convection-type super heater elements. Non-super-heated engines (Saturated Boilers) just have a boiler full of tubes. However, not all superheated engines have the big flues. Up to the 1920s, some locomotives had super-heaters built into their smokeboxes and not the boilers. Some earlier designs would run one leg of a super-heater element down one tube and return it along a leg inside ANOTHER tube – so the tubes were only slightly different in diameter.
