WORKDAY SUMMARY – 4 FEBRUARY 2017:

The main focus for the 4 February 2017 was the start of the 2017 Coach Lifting program. It isn't exciting work and it gets in the way of getting the locomotives done. But it is mandatory to keep the coaches in safe working order. Progress depends upon the number volunteers who come to assist on Saturdays.

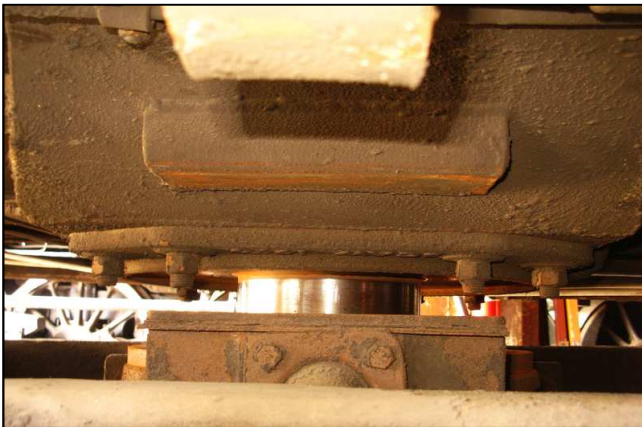
P02 - The main point of coach LIFTING is to disconnect the bogies, and to jack the coach up over the bogies for inspection of the pivot and its bearings. With the 40-ton coach being jacked up on both sides, you can see the shiny bolster pivot lifting away from the bearing boss right in the center of the picture. All the other jobs can usually be done with the coach resting on its wheels as normal.

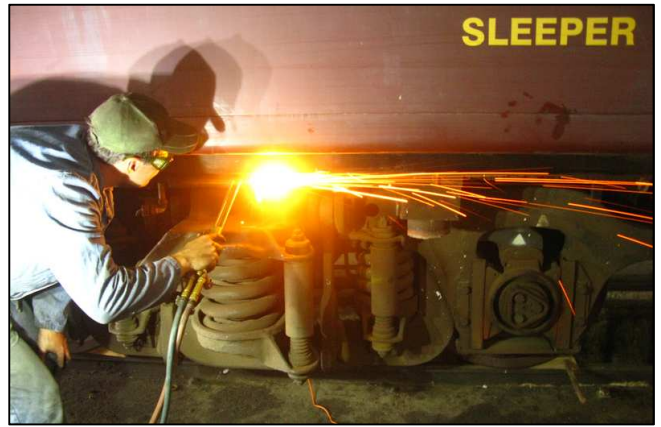
P03 - Over the years, we have removed obsolete and untidy steam heating equipment, battery bays, wiring, old pumps, axle-driven pulleys, etc. It opens up the lower coach body for access, and for addition of a train-lengthed water mains and also saves weight. (Over 8 tons on a full length tour train.) Dawie Viljoen is seen cutting away a now-unused hangar bracket for a steam heating pipe.

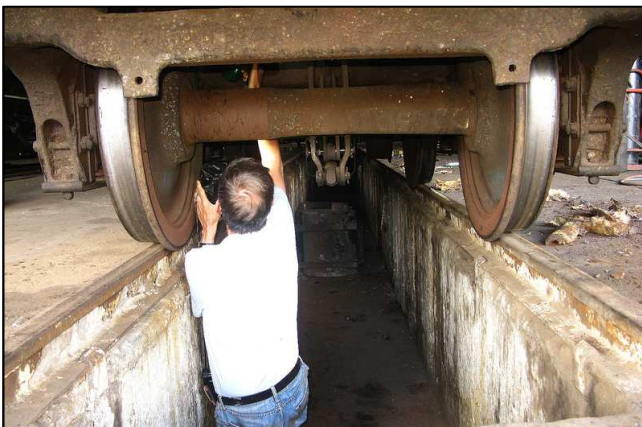
P04 - Coach lifting time is also used to give the brake linkages and suspension gear a good old-fashioned oil round. Here, Nicholas Goodale gets to work to lubricate the numerous pinned brake linkages and pivots.

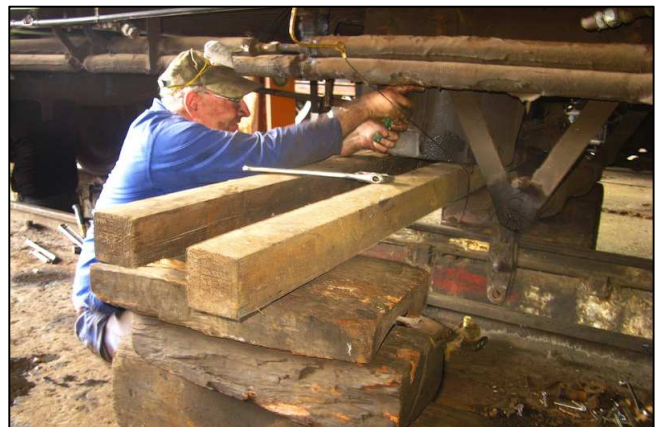
P05 - Aidan tackles the unbolting of the 21-inch brake vacuum pan for later removal. It was booked for a full strip down and inspection (And to be marked by a date when done), and new seals & roller ring as a matter of course.

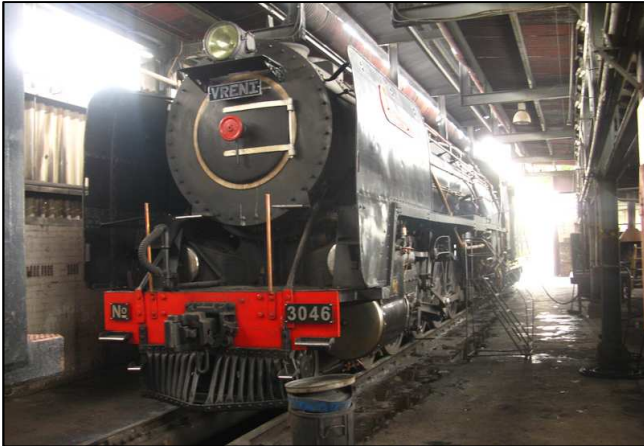
P06 - 15F No.3046 is now the bread and butter loco while we start work on the 15CA. (We would commence engineering work on the CA's boiler the following week.) The 12AR is awaiting funds for her boiler tubes and lower front tube plate thickness-repair.

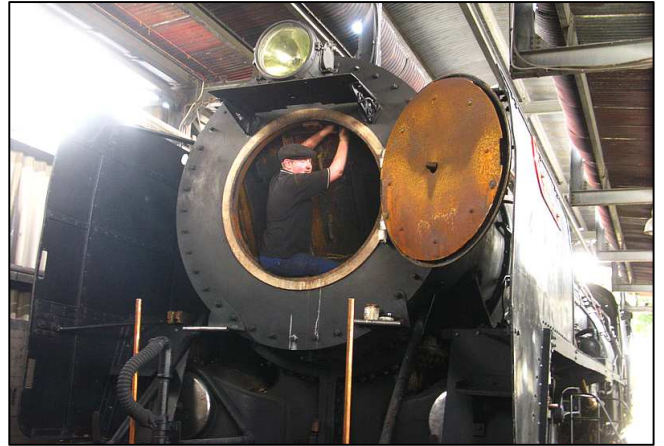
P07 - Our smokeboxes get opened and washed out after every trip. The char and clinker becomes corrosive if it gets damp and is just left in contact with the baked bare steel. While we have a staff member (Bongani) doing the strip and wash during the week, the Volunteer Members need to start putting the smokeboxes back together again.

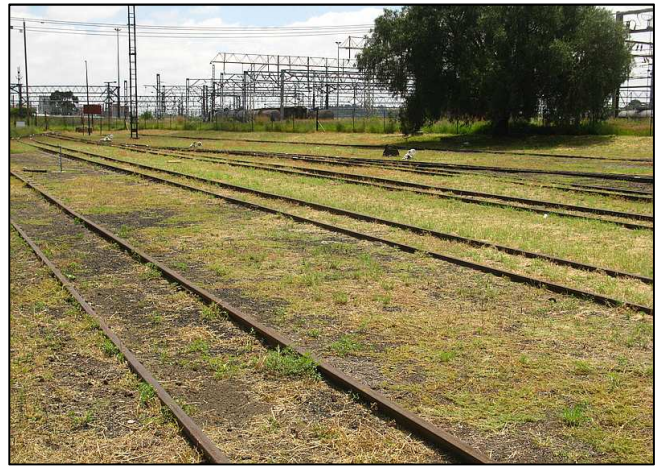
P09 - Peak summer time is a constant battle to keep the yards weed-free with bright sunshine and lots of rain on the warm, well-drained soil. This is less than a week's growth.

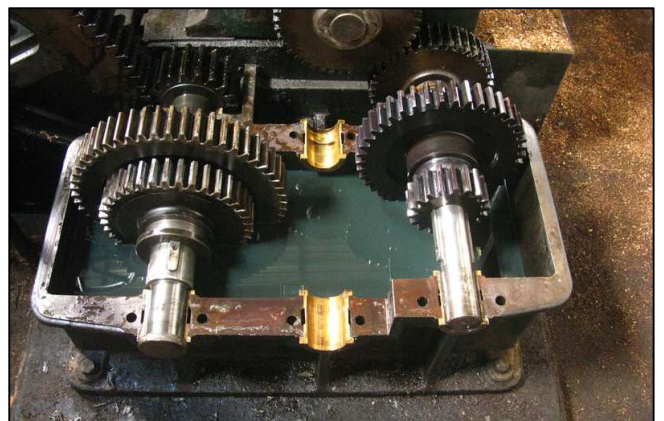
P11 - The 1922 Craven Wheel Lathe's Secondary Gearbox had been opened up for repairs. The gearbox itself is running great. But the shell bearings on the center (idler) shaft are slightly too oversized for the shaft and a lot of oil leaks out during operation. They are going to be cut back and re-lined with Vesconite to better suit the shaft.

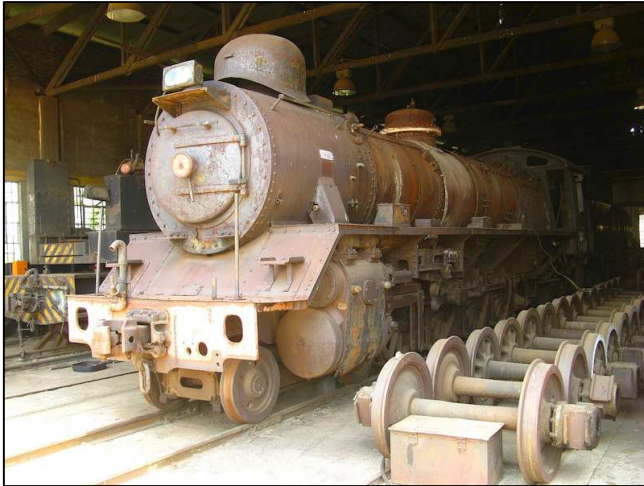
P12 - Ex-Millsite rescue Class 19D No.2540 had the boiler cladding and the underlying thermal lagging stripped off the previous weekend. (End of January)

At a quick glance, the exposed boiler shell looks fairly OK, but it still needs thickness testing, and MRI work at critical points as is now standard when assessing 'stored' locomotives. Long-exposed locos like this one sometimes develop deep localised pitting in the boiler shell, which necessitates expensive patching repairs.

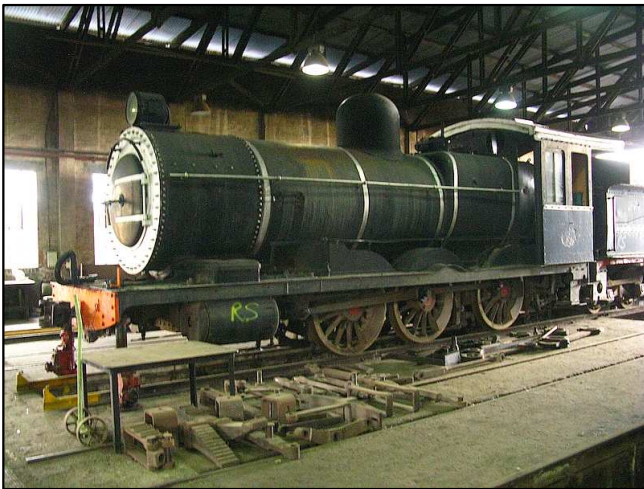
P13 - Ex-SANRASM Hyde-reboilered Belpaire Class 6A (No.454 b. 1895) looks a lot happier in Bay No.2. She has been purchased for private and personal restoration by Shaun Ackerman. She last ran in 2009. The boiler and smokebox had been repainted at SANRASM in 2011.

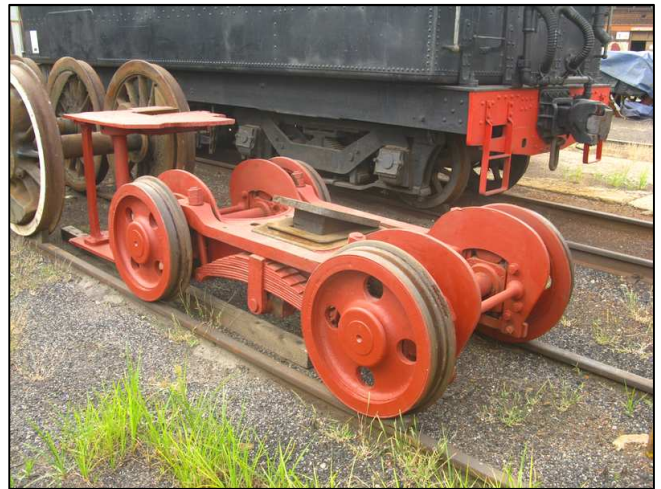
P14 - Here is the intact spare bogie for Class 6A No.464 previously pictured, and a repair section for the theft-vandalised frames just behind. Valve gear components await fitting from the Millsite Store and the loco's chimney and other parts are stored in the tender(s).

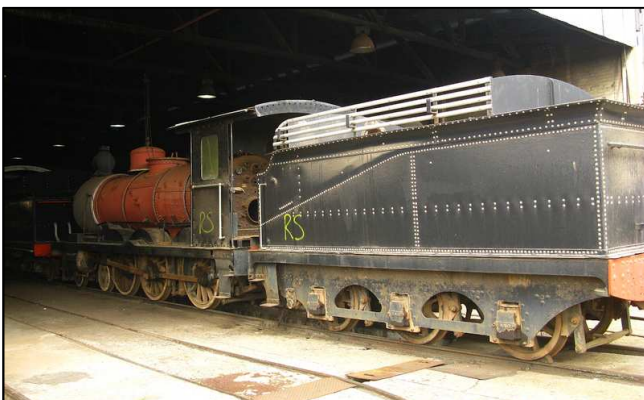
P15 - Saturated-boiler Class 6A No.473 (b. 1897) is parked neatly behind No.454 and is now owned by Clive Holliday who will also be doing a private restoration. 50 Class 6As were built between 1895 and 1897. Both of these little Cape Government Railway locomotives are 10-wheelers, being 4-6-0s. Both of these locomotives are to be private restorations and not formal Reefsteamers Projects, or by using Reefsteamers funds.

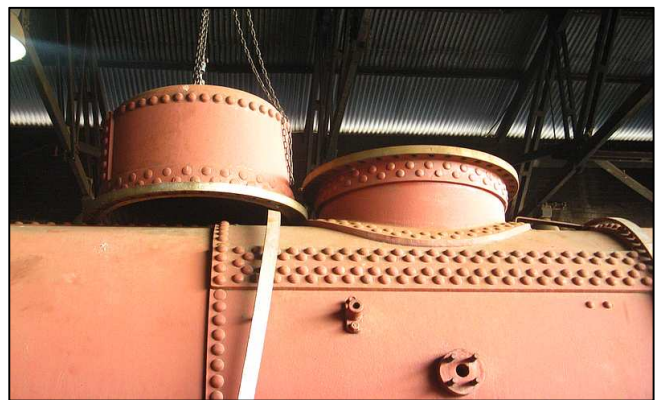
P16 - No.473's dome cover had already been lifted off to facilitate internal boiler inspection. The boiler is 100% full of brand new tubes which have never been used once. But all of them have been 'safe-ended' as someone had made a mistake and cut them too short, either from bad dimensions or because of front tube plate deflection. When PROPERLY done, tube safe-ending is acceptable, but a poorly-done job makes a failure point in a pressure vessel. It is very likely that the boiler will need to be completely retubed again for a long-lasting repair.

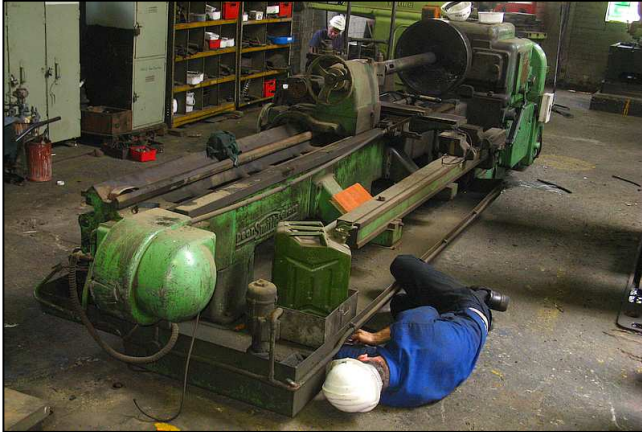
P17 - On 7 February 2009, the recently donated 7-Ton Dean Smith Grace Lathe was levelled out (Pictured), wired up and commissioned for its first RS job. This lathe was donated by Andrew King's old firm, Boswell Engineering, who helped us in numerous ways over the years.

The big lathe's first RS job was to machine the crosshead taper on the 12AR's left-side piston rod, the worn taper having been built up by welding during the week.

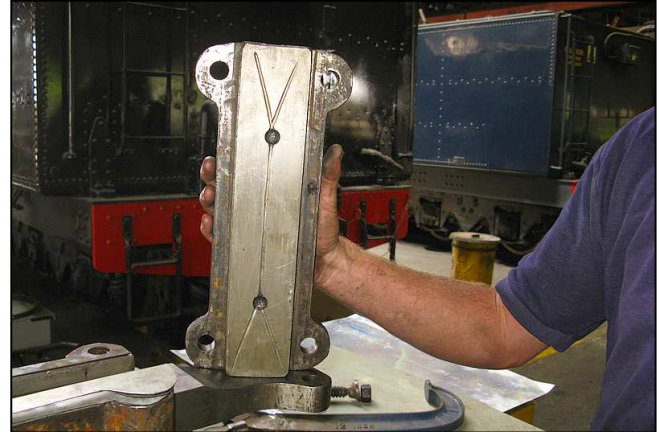
P18 - The planar bearings of a steam locomotive usually have oil distribution grooves cut into the white-metal bearing surfaces. These are usually made AFTER the bearing surface had been machined to suit the application. The grooves are then smoothed with a shaping spoon if necessary, especially if the job was done manually.

This is the under-plate for the valve crosshead for the 12AR and you can clearly see the two points where the lubricant is applied. In this case, the lubricant is grease and thus extra effort had been made to extend the grooves to the corners. By contrast, the main crosshead is lubricated via a pair of traditional oil-wick cellars.

The repair for the day was the making of new shims for the crosshead. You can one of them at the lower left.
